EGG-HWP-8128  
August 1988

FINAL REPORT

DISMANTLEMENT OF BUILDING 666 AND INDUSTRIAL  
WASTEWATER TREATMENT PLANT NO. 4

This report describes the tasks performed to dismantle Building 666, Industrial Wastewater Treatment Plant No. 4, and associated facilities at McClellan Air Force Base (AFB). This report also presents the condition of the site after dismantlement and identifies the cost and duration of the project, and hazardous waste volume generated.

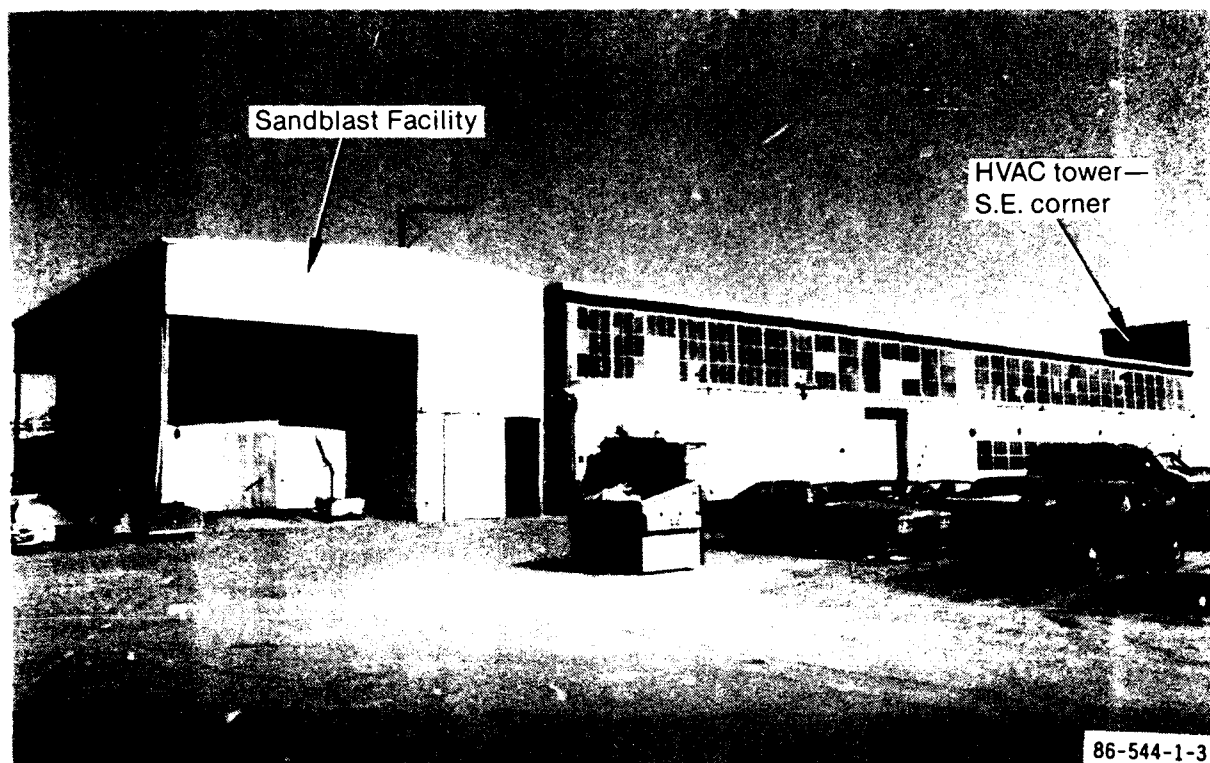
Figure 4. Building 666 south side with Sandblast Facility at left.

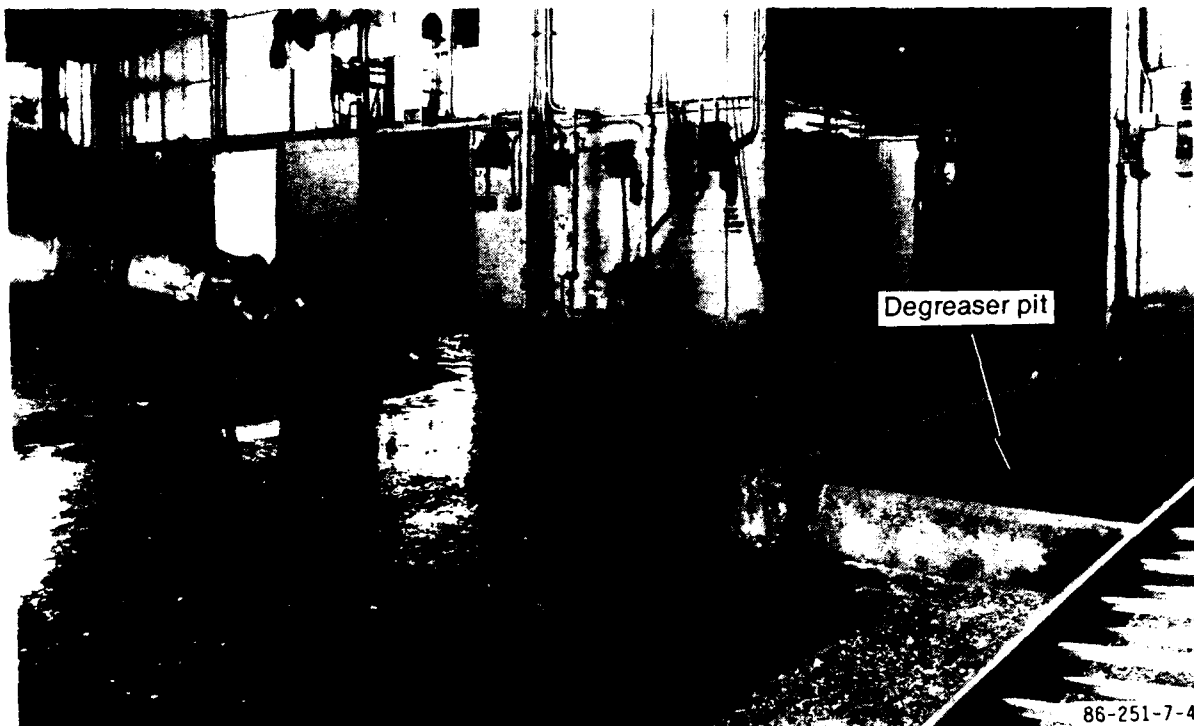
In 1982, the rooftop-mounted ventilation units were removed along with the built-up roofing material. The ventilation roof penetrations were then sealed with sheetmetal caps and the roof recovered with built-up roofing materials. During this roofing modification, the toxic exhaust ductwork was cut loose from the roofing vents and allowed to drop to the building floor (Figures 6 through 10).

Figure 7. Building 666 interior, rough cleaning and pickling area looking northeast.

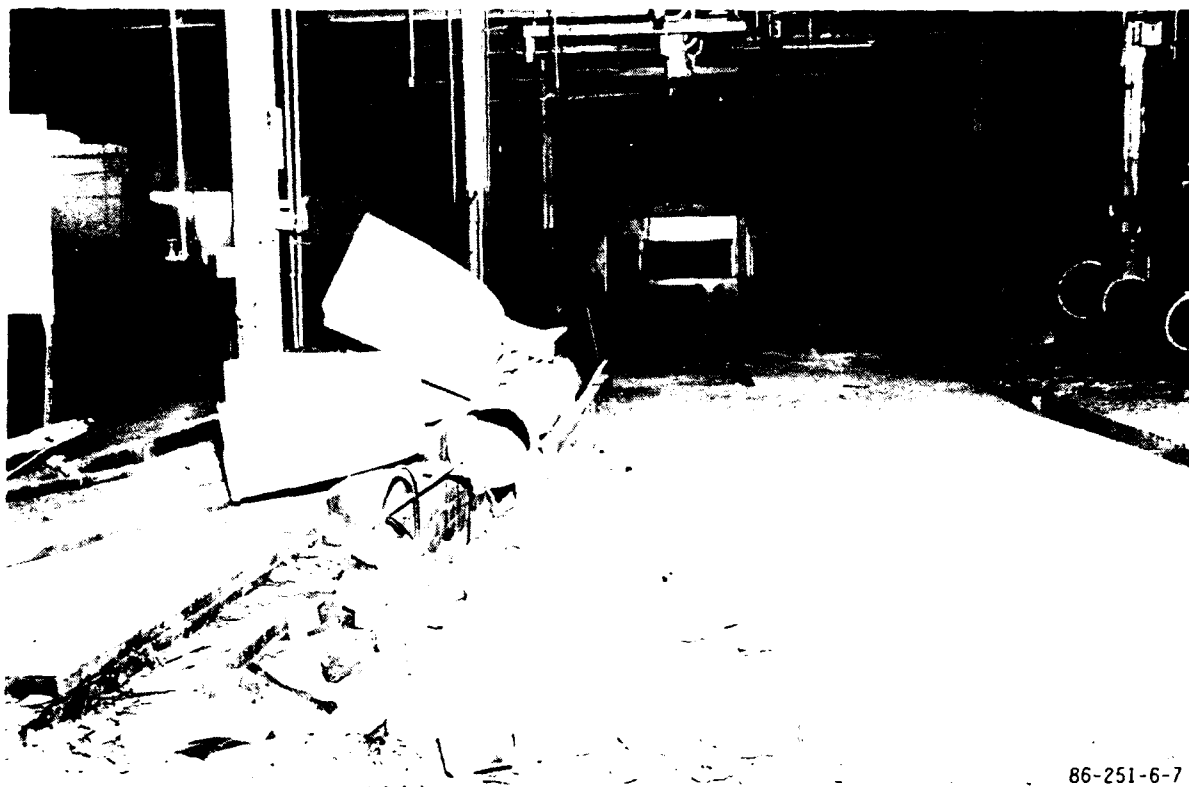
86-251-6-7

Figure 9. Building 666 interior, gold and silver plating area looking west.

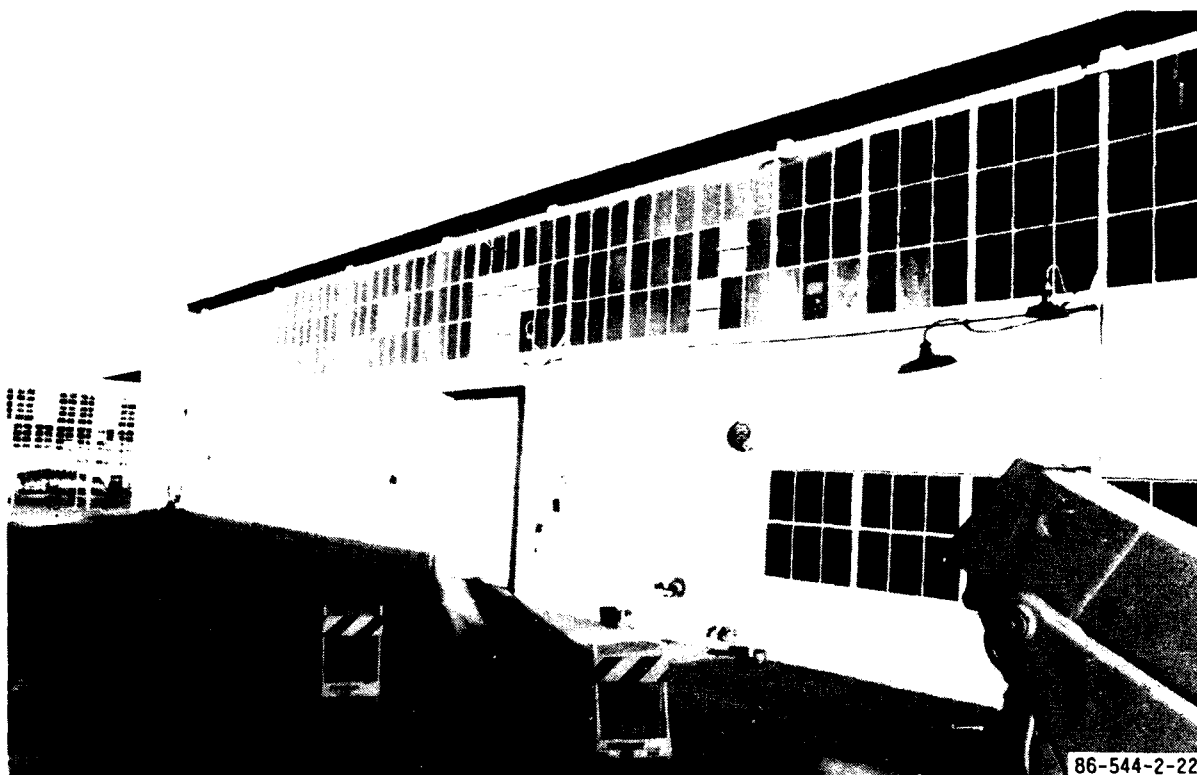
Building 666 had broken windows, open windows, open doors, and louvers in the three HVAC towers which, if not closed, would have allowed airborne contamination to leave the building once work began inside the building. All these openings were closed before activities started inside the building (see Figures 23 and 24).

Figure 23. South side of Building 666 showing boarded-up broken windows, closed windows, and closed doors.

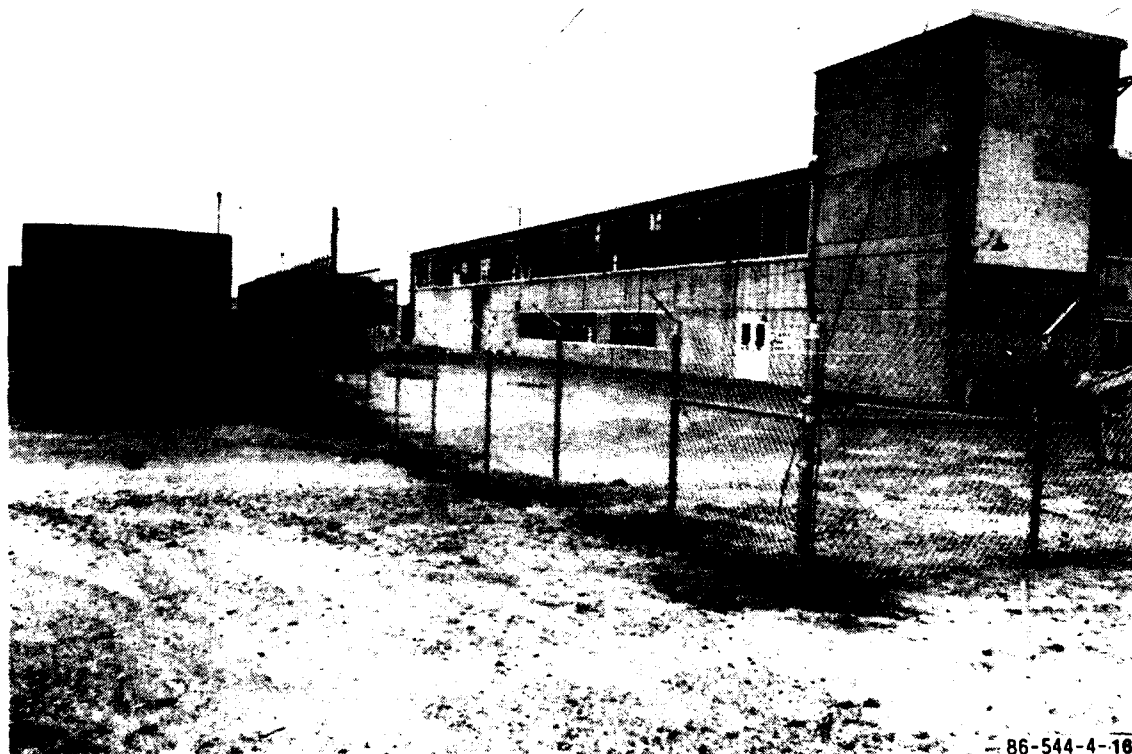
Figure 24. HVAC tower on southeast corner of Building 666 showing boarded-up louvers.

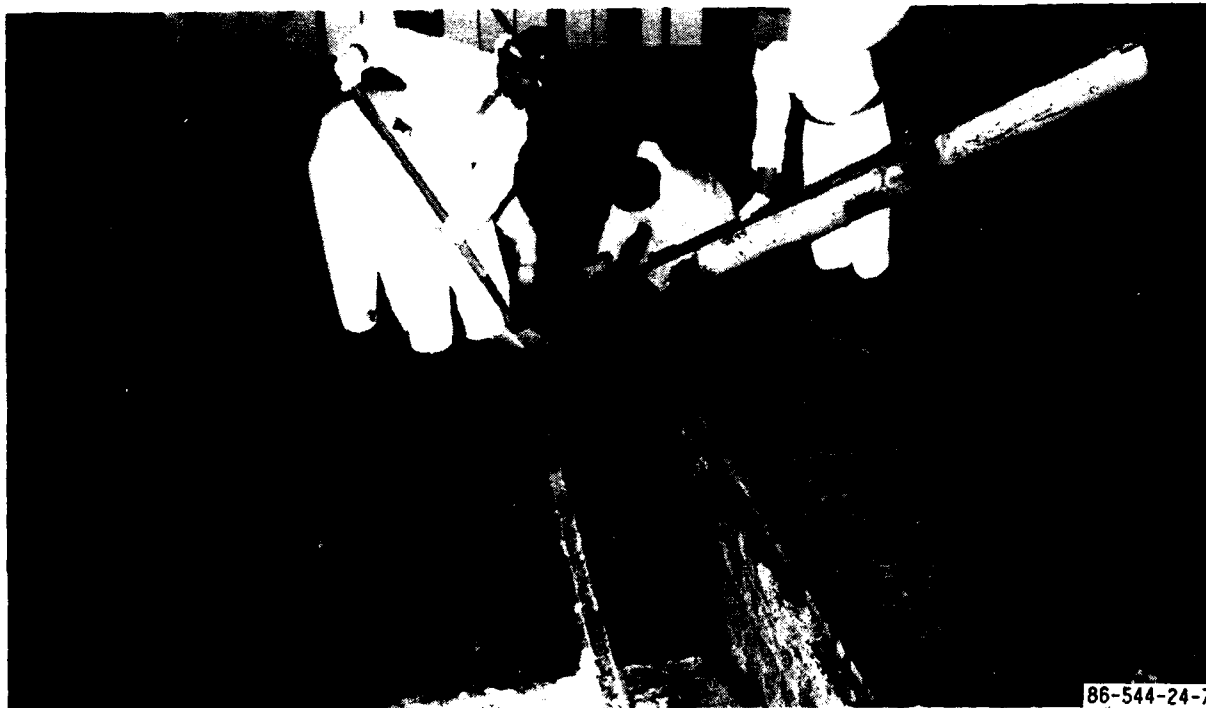
86-544-24-7

Figure 38. Filling trenches with concrete.

After the bricks were removed from the trenches, the trenches were cleaned of debris, vacuumed, and filled with concrete (Figure 38). Forms were constructed to prevent the concrete from flowing into the sumps (Figure 39). When the concrete had set up, ripout of the building was completed, all remaining debris was transported to the disposal site, the entire floor area was swept, and the entire interior of the building was washed down with high-pressure water (Figure 40). The liquid from the washdown was collected in the sumps and pits, analyzed, and later disposed of in the McClellan AFB IWCS. This washdown of the building interior to

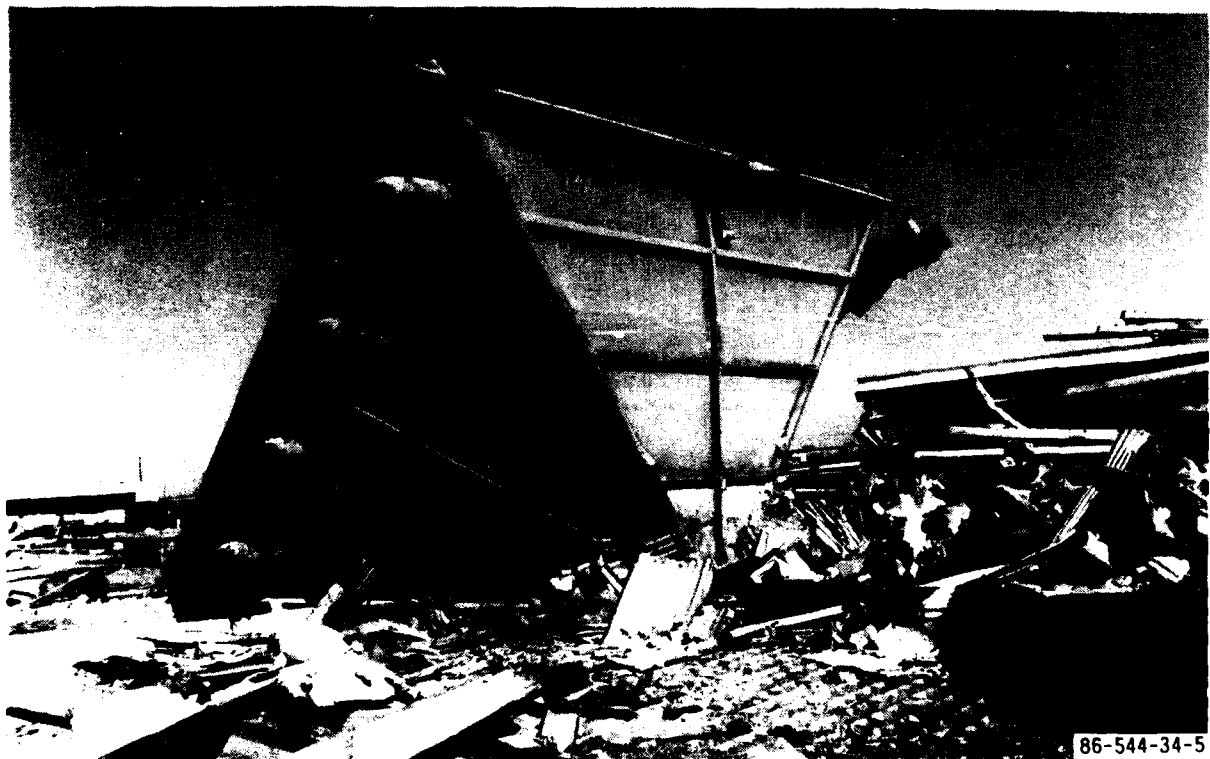
The substructure beneath the northwest bay of the Sandblast Facility consisted of a cone-shaped steel structure (Figure 60), which was removed from the pit, sheared, and placed in waste bins for shipment to the disposal site.

Figure 60. Cone-shaped substructure from Sandblast Facility northwest bay.

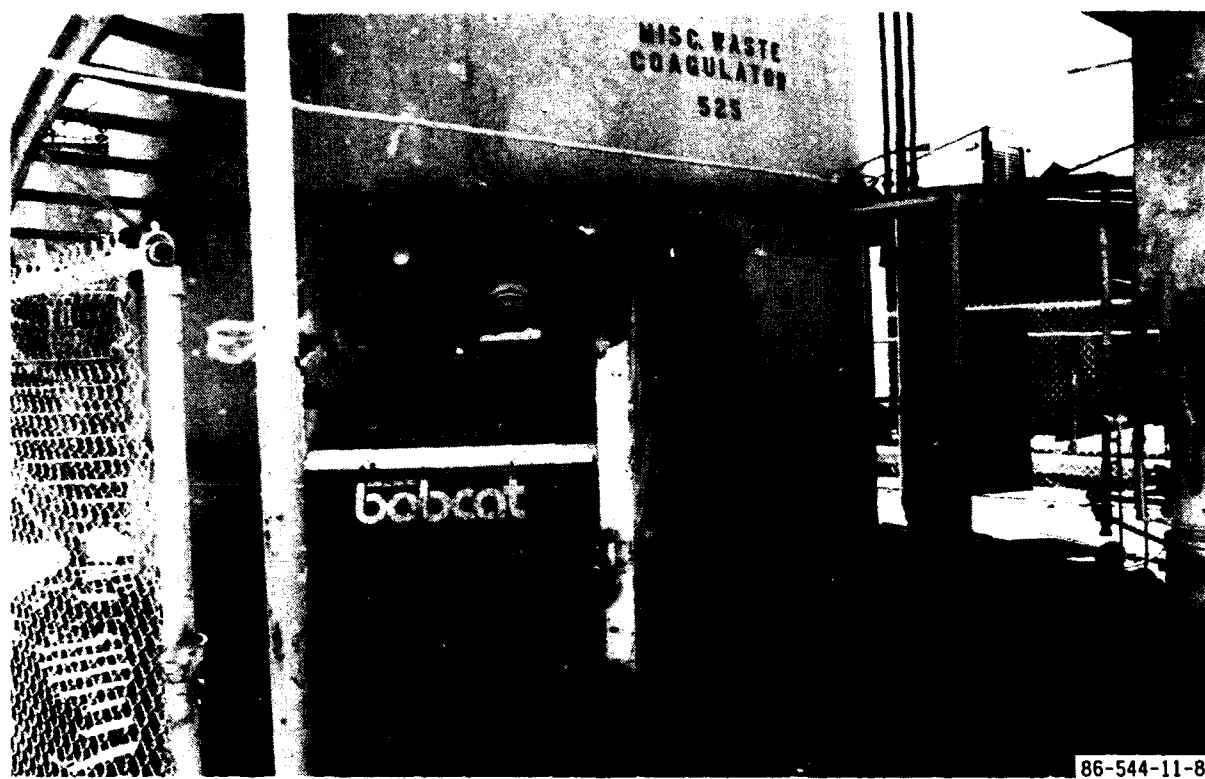
Several of the tanks contained sludge. The open-topped tanks contained dry sludge because the previously accumulated rainwater had evaporated. Tank number 525, the coagulator tank, contained approximately 120,000 lb of dry sludge. Six ion-exchanger tanks contained resin. The tanks containing sludge were accessed by torch cutting a hole near the bottom in the side of the tank. Each tank was then entered, the sludge removed, and the tank interior cleaned and vacuumed (Figure 63). In the case of Tanks 526 and 527, the rubber lining was also removed (Figure 64).

Figure 63. Sludge being removed from Tank 525.

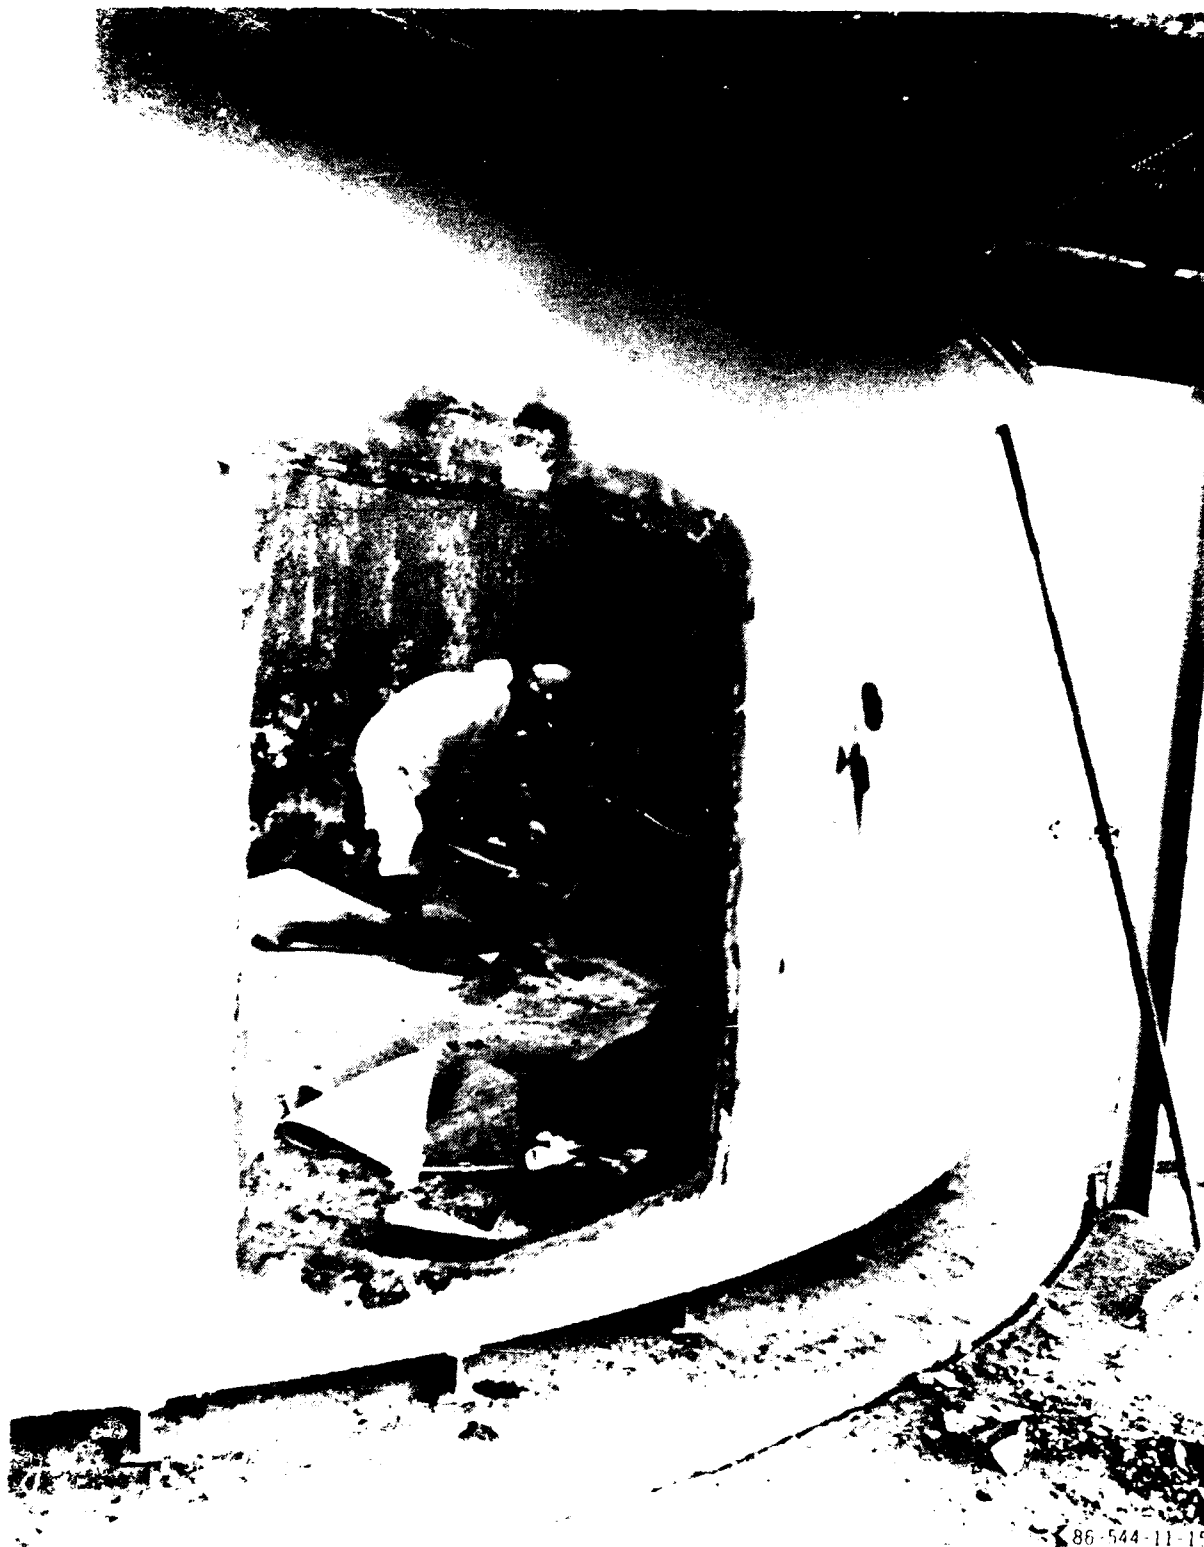
Figure 64. Interior liner being removed from Tank 526.

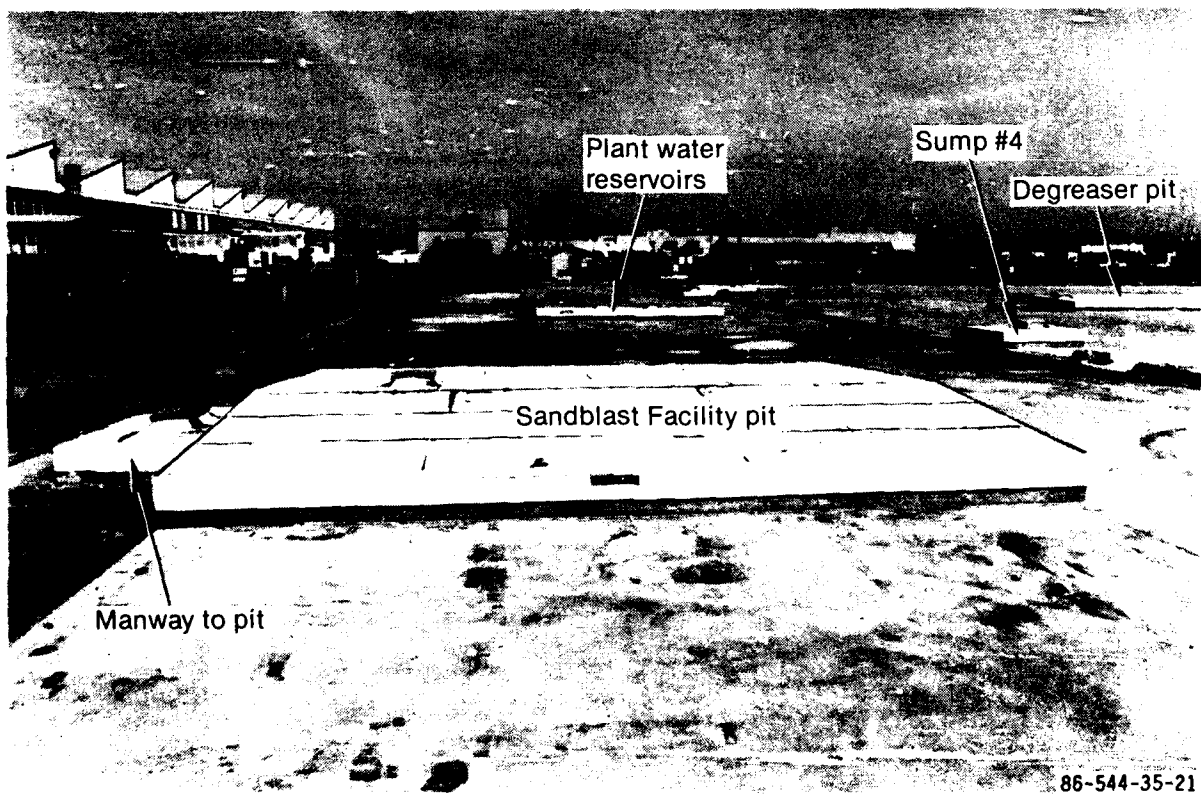
The roof structure above the Sandblast Facility pit and manway to the pit has an inspection port above the manway and one above the deepest part of the pit (see Figure 78).

Figure 78. Roof structure above Sandblast Facility pit and manway.
